PROJECT OVERVIEW

Mallard Lake is a 6.5 acre private stormwater lake located in SE Wisconsin. It has three main fingers and three small islands located on the southern portion of the lake. The maximum depth is 10.9' while the average depth is 5.1'. Despite having a 12-diffuser summer aeration system and a SolarBee for winter aeration, the lake saw extensive fish kills during the winters of 2009 and 2014.

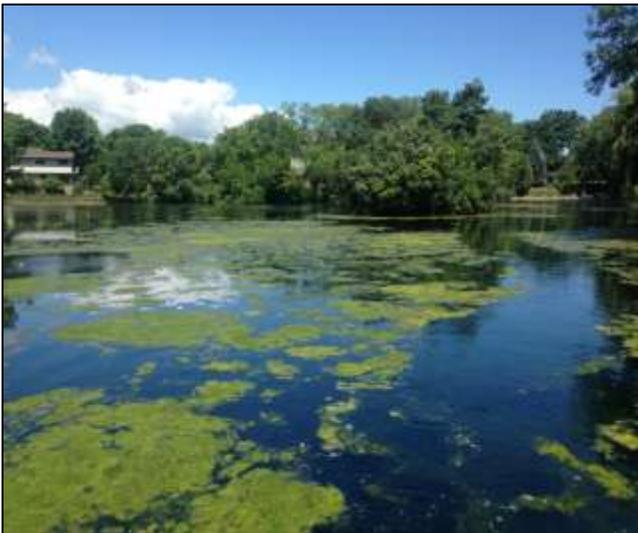
Hydrodictyon growth on Mallard Lake (2014)

Following a 2014 fish kill, total phosphorus and dissolved phosphorus in the lake quadrupled to 0.280 ppm and 0.110 ppm, respectively. As expected, algae growth exploded including difficult to control species like hydrodictyon, pithophora, and spirogyra.

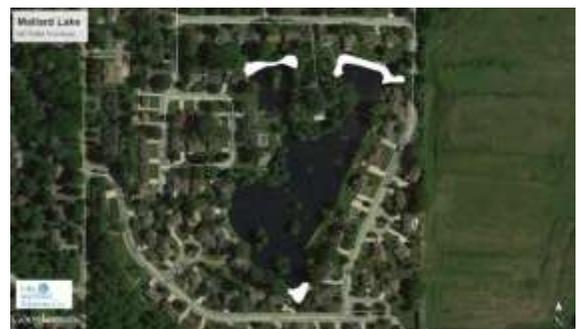
Due to the sheer size of the pond, 3 key areas of excessive soft sediment accumulation were chosen as test sites (see inset picture on right). The NW area was 0.16 acres in size, the NE area was 0.17 acres in size, and the South area (near the outflow) was 0.09 acres in size.

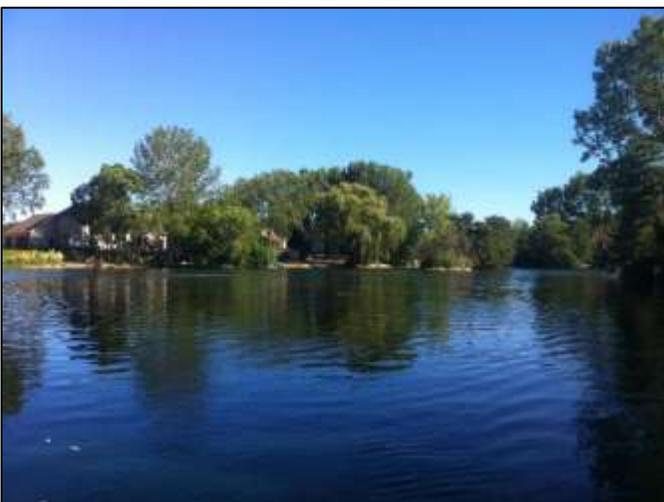
Mallard Lake Muck Depths				
NW LOBE				
DATE	MIN	MAX	AVG	Readings
3/28/2016	9	21	14.25	15,9,21,12
9/15/2016	0	18	8.4	18,6,0,6,12
NE LOBE				
DATE	MIN	MAX	AVG	Readings
3/28/2016	6	42	16.5	15,9,18,9,6,42
9/15/2016	0	42	13.5	0,9,0,6,42,24
S LOBE				
DATE	MIN	MAX	AVG	Readings
3/28/2016	21	24	22.5	21,24
9/15/2016	6	12	8.0	12,6,6
SW LOBE (Control)				
DATE	MIN	MAX	AVG	Readings
3/28/2016	8	17	12.4	8,14,12,17,11
9/15/2016	7	17	12.8	7,12,17,13,15
<i>Data collected by Lake and Pond Solutions Co. (2016)</i>

In the NW and South areas, average soft sediment was reduced by 5.85” – 14.5”. Those same areas also saw reductions in each minimum and maximum reading. The NE area did not show as much of an average reduction (3”) although the minimum reading did decrease. It should be pointed out that the NE end of this area is where the most extensive muck in the lake was found (42”). No aeration is present there and it’s theorized that oxygen demand was too great to achieve dramatic results. The control site, located at the SW end of the lake, saw no significant changes to soft sediment levels.

Triton SRP applications of 42#/acre resulted in reductions of 3” – 14.5” over the span of all test areas. These results were confirmed by two separate Mallard Lake HOA members who performed their own soft sediment testing. In their sampling, they showed average reductions of 5.58” with maximum reductions up to 18”.
